## Sun Mountain Ranch Club

# Community Wildfire Risk Assessment

July 2020

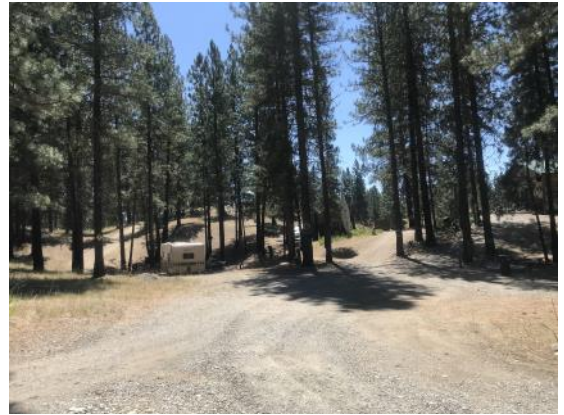
Trees too close to the road that could pose a hazard during a wildfire event

*Recommendation*- For the lots with the longest (300'+) driveways, ensure there are turnarounds at each residence as needed. Prune trees along roads to 14' high for fire truck access. Fire trucks are the size of large motor home and will need a big enough space to turn around. Identify turn around spaces with a sign and keep grass mowed low so it does not spark a fire if a vehicle turns around.

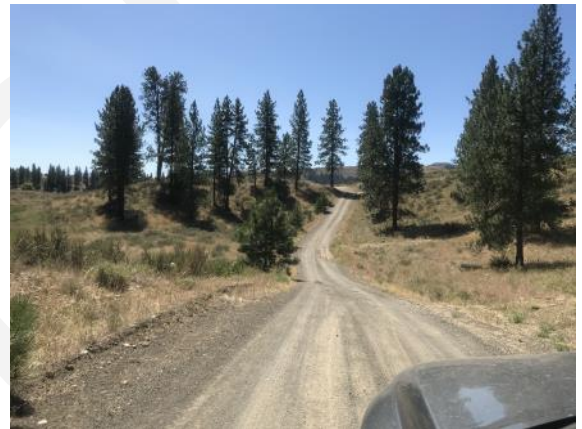
Dry grass on road shoulder.

*Recommendations*– There is a significant population of dry grasses along the road which can be highly flammable. Keep vegetation near roads cut back so that there is less risk of a vehicle igniting dry vegetation should it need to pull over to the shoulder. Where needed trim trees and tree limbs over hanging the road. For reference trees and limbs should be treated 30 feet from the center line out to the road shoulder.

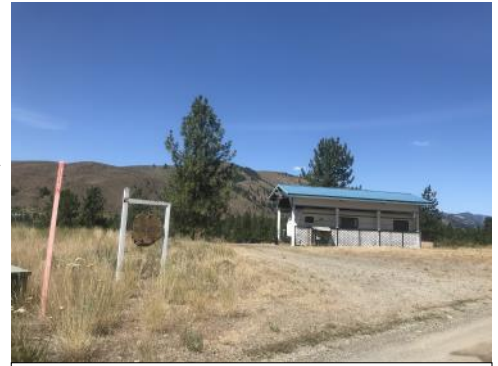
Homes have a wide range of house number styles that are hard to read and would be nearly impossible to read during dark smoky conditions.

House number that is difficult to see and not reflective

*Recommendations-* The wooden house signs are difficult to read. These should be replaced with standard reflective signs. Ideal addressing is 4" in size and reflective. Reflective address signs should be used and placed so that they can be easily seen from a vehicle at night driving on the road. This will ensure the emergency responders can find locations quickly. Additionally, addresses should represent the county-approved E-911 address, not the lot number within the development. For homes with long driveways, it often makes sense to have two signs, one at the intersection with the road and driveway, and one on the home itself.

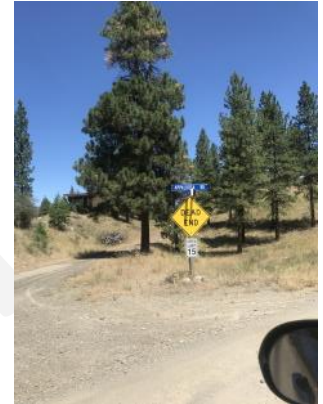
Reflective street sign and dead end sign that are easy to see by emergency personal.

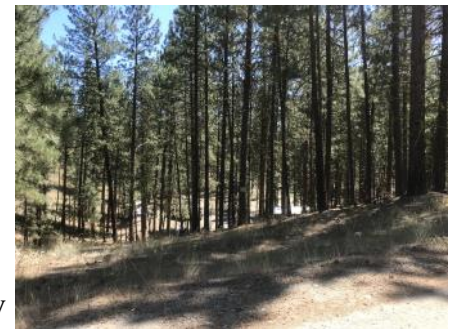
Dense forest area within the community.

*Recommendations:* Encourage all property owners to have an individual risk assessment completed so that specific recommendations can be made for their particular circumstances. In general reducing the brush and vegetation around the structures will help reduce fire intensity. Keep grasses, especially near homes and roadways, low during fire season. Grasses that are mowed once dormant will not regrow until moisture returns in the fall. Irrigated grasses which are kept green will be less likely to ignite. Ideally, these management actions will keep fire on the ground. Encourage home owners living on top of slopes to cut brush down slope at least 100 feet down. If they have a deck, recommend adding metal skirting under deck to block embers and debris from entering. Encourage home homeowners with forested property to do thinning work such as pruning and spacing out tree canopies 20 feet apart. In the shrub steppe area create islands to break up flashy fuels. You can do this by picking 5-10 shrubs as part of an island and mow a 5 feet path around that island. This can be a lot of work and maintenance so encourage landowners to start near the home and work out over time.

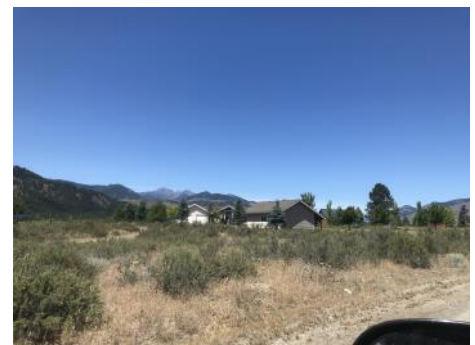
Shrub steppe. Very flashy fuels

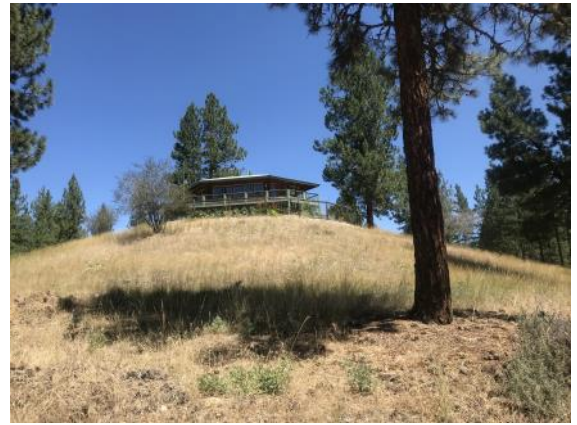
Home on top of steep slope

*Recommendations* – Owners whose property backs up to the steepest slopes should be aware that burning material often rolls downhill during wildfire events. Efforts should be made to reduce the likelihood that any of this rolling material make contact to the home or the fuels that lead to the home. Fire can also travel up hill at high rates and special attention needs to be made to that side of the homes that are at the top of the slopes. Homes will require individual risk assessments to properly advise actions to mitigate this specific concern.

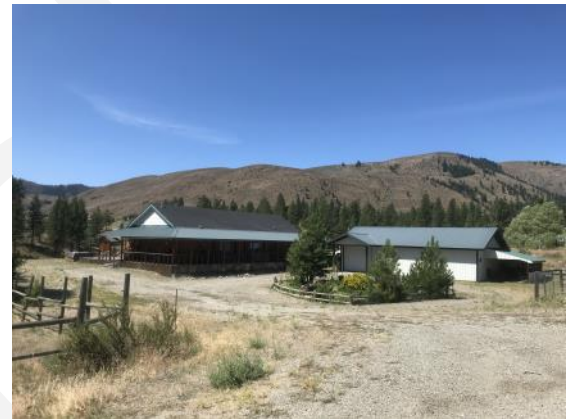
Outbuilding close to home.

*Observations* - Individual homes and structures were not assessed for separation from adjacent structures. The overall impression is that lots are large enough so that residences are fairly well separated from others,. However, a number of homes have outbuildings close to the homes themselves. A lack of separation increases risk because additional structures provide additional sources of fuel. These structures, should they ignite, will threaten additional homes and forested areas. Each homeowner needs to be aware of their garages, shops and other buildings on their property and maintain defensible space around each. Sheds and other similar structures can act as ladder fuel if positioned underneath trees. If a shed is under a tree, move the

structure to an open space or cut the tree down if possible. If that is not an option, trimming over hanging tree branches will help.

*Recommendation* - Each resident should be evaluated on the separation of structures. All structures on a parcel should have defensible space around them to prevent them from catching on fire and threatening homes. This includes garages, wood sheds and shops.

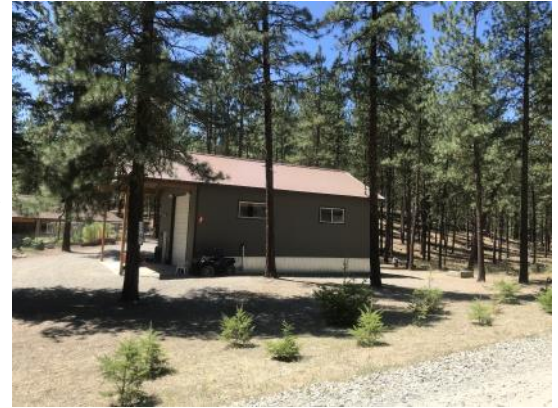
Home with defensible space and fire resistant roof and siding.

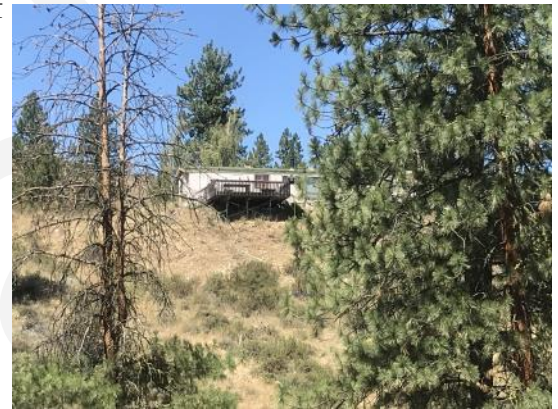
Home on steep hill side with wood deck.

*Recommendations*— Encourage homeowners to add 1/8th inch metal mesh screening or metal skirting under decks. The resulting embers from a wildfire can blow under decks and ignite vegetation underneath. Encourage new home construction and decks to be built with fire resistant material. Adding metal skirting around bottom of structures especial on ones with wood siding will help prevent a ground fire making contact to the wood siding. To protect campers remove vegetation near and over hanging the camper. Check vents on homes, outbuildings, and camper trailers. It is recommended that vents be 1/8 inch in size and made of metal mesh. It has been studied that the 1/8 inch size keeps most embers out of a structure but still allow ventilation.

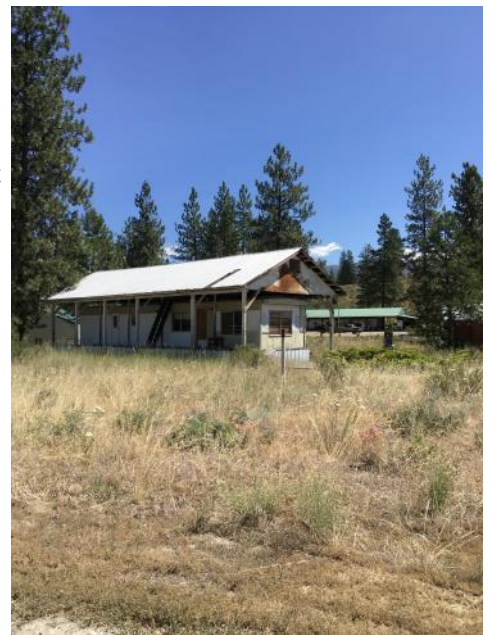
Trailer home with flammable siding .

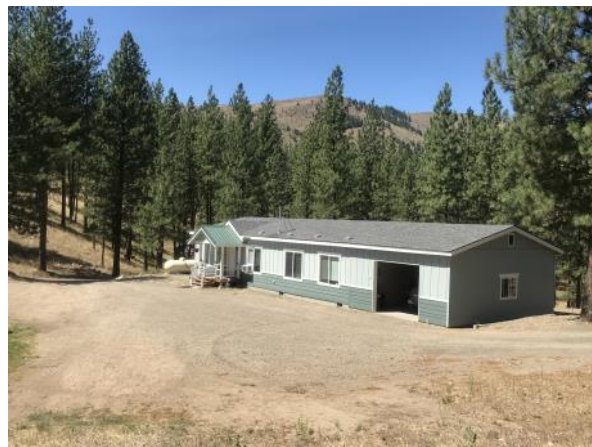
Home built with fire resistant composite roofing, metal skirting to keep ground fire from touching siding, 30 ft defensible space around home.

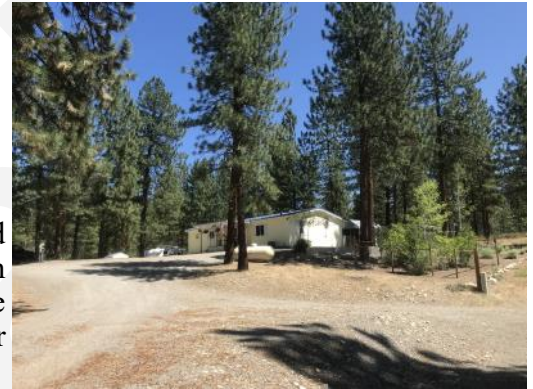
Tank is located away from home but placed under trees. If trees were to ignite it could cause tank to ignite as well.

*Recommendations*— If residents have a propane tank, keep brush and over hanging branches away from tank. Adding a 5 foot gravel perimeter around tank to keep brush back will help. If tank is placed up against a home, recommend moving tank 30 feet away from structures if possible or bury the tank.
